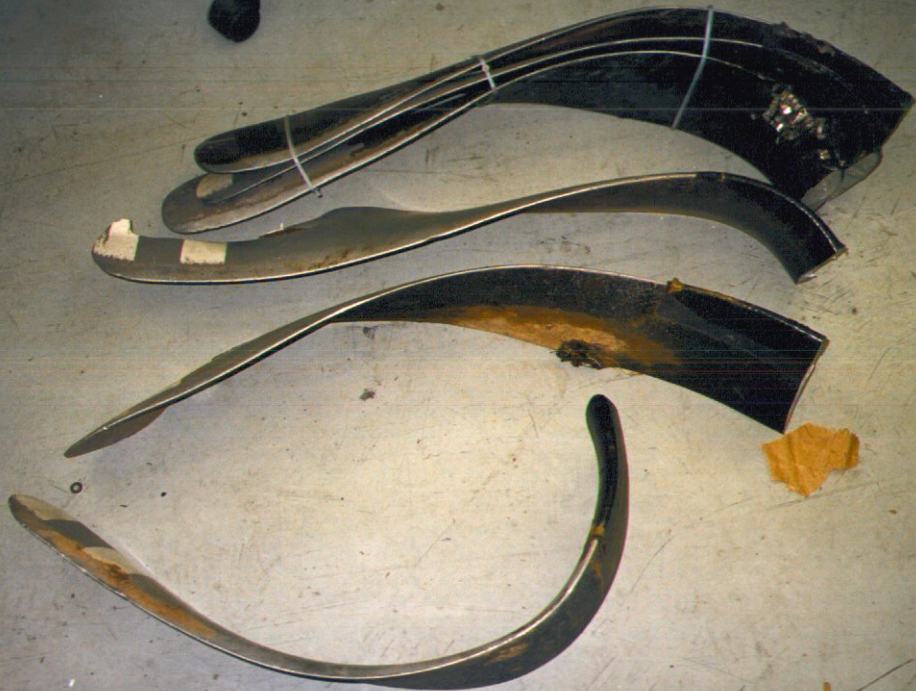
Photo 17: View of engine propeller blades as received at engine inspection facility. All were cut at blade root to facilitate shipping.
